**Flood Control Project Maintenance  
Levee Inspections**

**Fall 2015 Levee Maintenance Deficiency Summary Report**

**San Joaquin River Basin**

| <b>RD0404</b> | Overall LMA Rating | Total LMA Miles | * Overall LMA Threshold Percent is less than 10.00%; however, U Rated Miles are present, so the Overall LMA Rating is M instead of A. | | | | | |
|--|---|---|---|---|---|---|---|---|
| <b>Reclamation District No. 0404 Boggs</b> | <b>M *</b> | <b>4.10</b> | | | | | | |

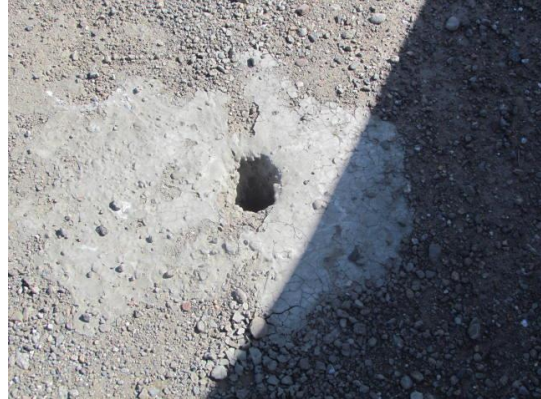
Photo 2 of 4 : FA\_2015\_RD0404\_305\_5\_20150914\_00005.jpg

Looking at partially grouted rodent hole on levee crown

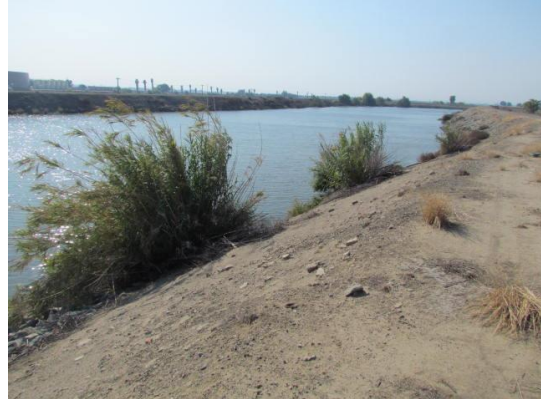
Photo 1 of 3 : FA\_2015\_RD0404\_305\_104\_20150914\_00022.jpg

Looking northwest at bamboo on waterside toe.

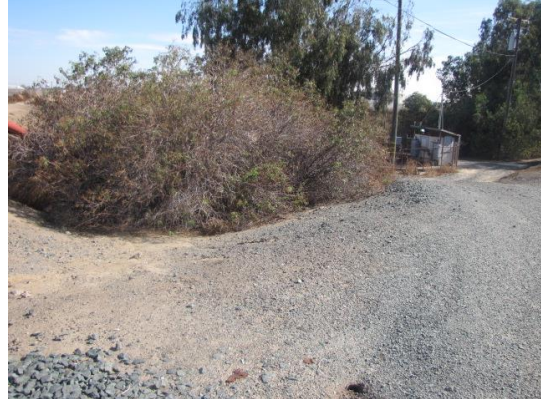
Photo 1 of 1 : FA\_2015\_RD0404\_305\_7\_20150914\_00008.jpg

| Elderberries are blocking visibility and flood fight capability. | | | | | |

Looking southeast at elderberry on landside slope.

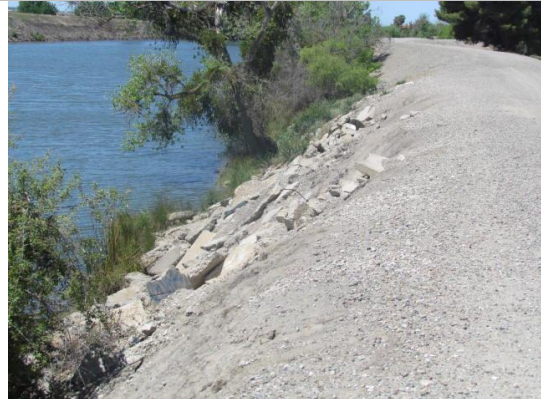
Photo 1 of 2 : FA\_2015\_RD0404\_305\_23\_20150914\_00014.jpg

Looking west at concrete rip rap with rebar. (Spring 2015)

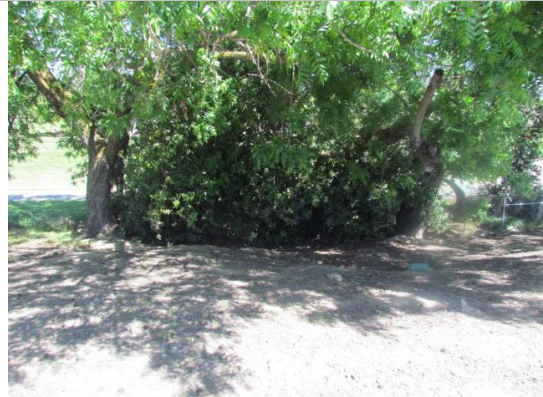
Photo 3 of 4 : FA\_2015\_RD0404\_306\_67\_20150914\_00009.jpg

| Inspector Comments: Dense vegetation around propane tank inside fenced area. | | | | | |

Looking northeast at dense vegetation on landward toe. (Spring 2013)

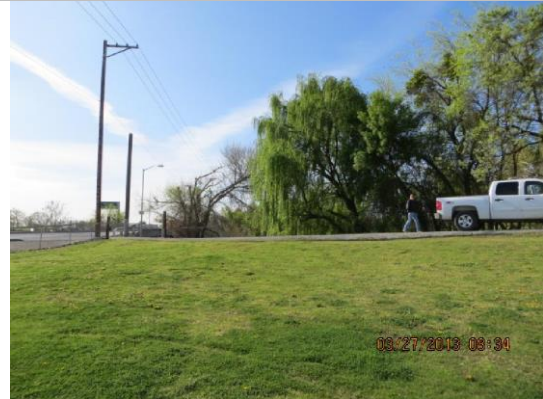
Photo 1 of 2 : UCIP\_FA\_2015\_0649.jpg

| Inspector Comments: FS_ID:12426<br>DS_ID:18787<br>EP_NO: N/A<br>FS_HLM: 1.7601<br>Repair Type: Non-Urgent<br>Crossing Status: Indicator Found<br>UCIP Comments: Only a 7 ft x 14 ft concrete vault found on LS.Needs a sign post.Bob Winter from KSN(representative of RD 404) will investigate on this crossing.<br>FIELD_STRUCT_DESC: 2 of 2. 42-inch-diameter pipelines under the levee. Pipes cross under the channel.<br>FS Date: 03/27/2013 | | | | | |

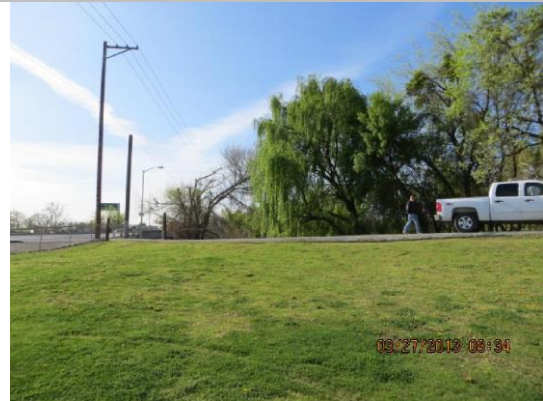
Photo 1 of 2 : UCIP\_FA\_2015\_0328.jpg

| Inspector Comments: FS_ID:10846<br>DS_ID:18804<br>EP_NO: N/A<br>FS_HLM: 1.76<br>Repair Type: Non-Urgent<br>Crossing Status: Indicator Found<br>UCIP Comments: Only a 7 ft x 14 ft concrete vault found on LS.Needs a sign post.Bob Winter from KSN(representative of RD 404) will investigate on this crossing.<br>FIELD_STRUCT_DESC: 1 of 2. 42-inch-diameter pipelines under the levee. Pipes cross under the channel.<br>FS Date: 03/27/2013 | | | | | |
